# Moose Flutter Incident

## Overview

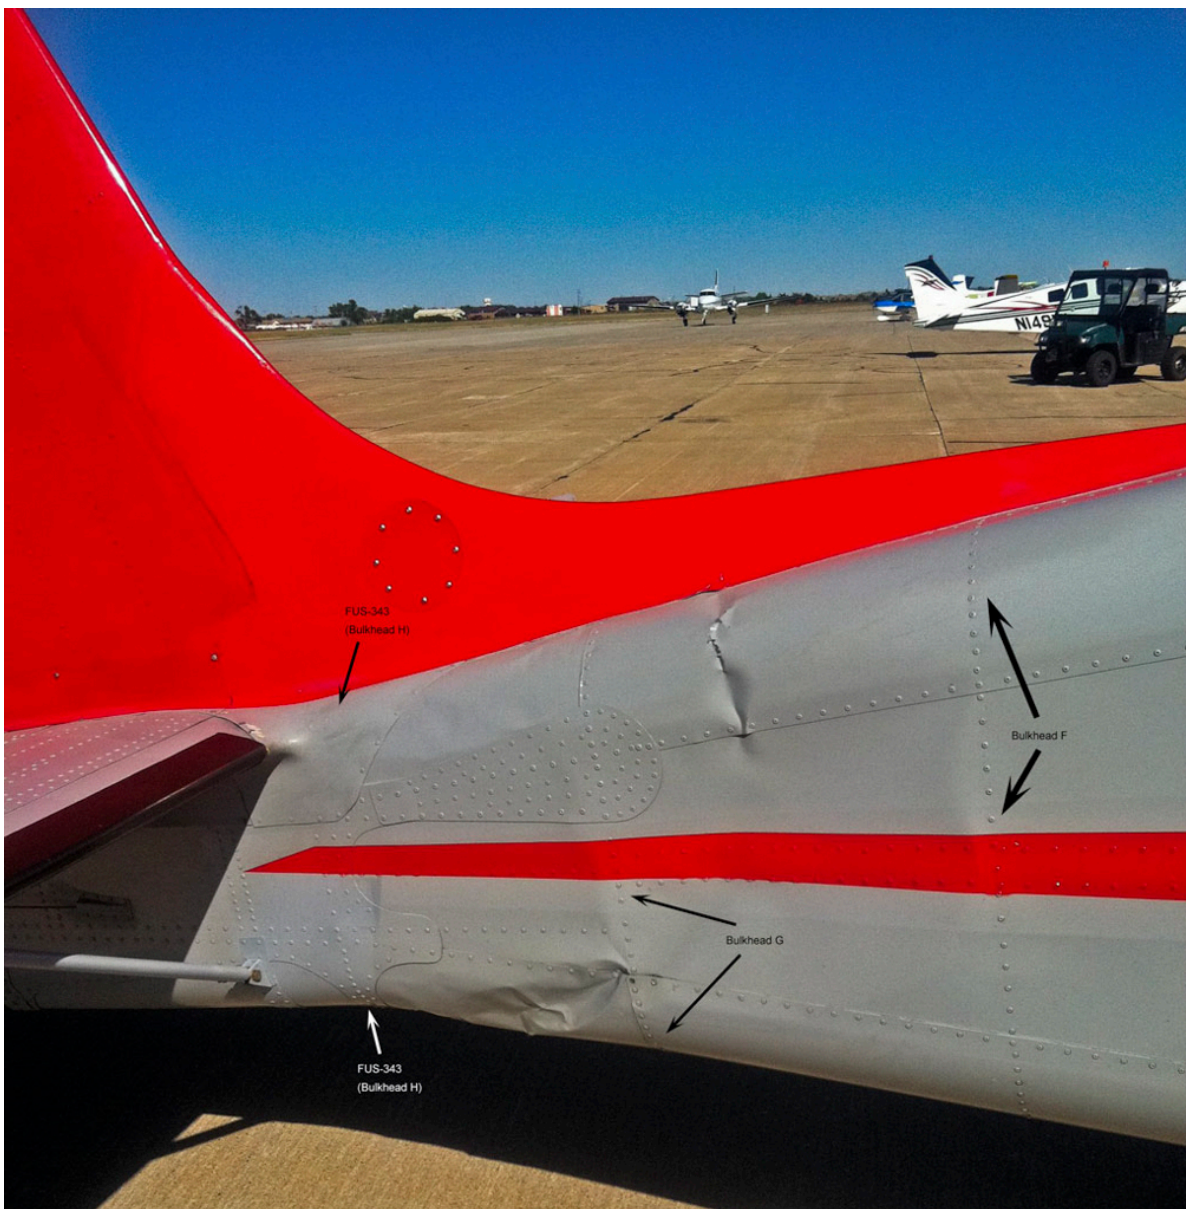
When we landed, we saw—and were astounded by—the damage below.

Why did the incident happen? We had numerous experienced Moose builders as well as an engineering firm analyze the pictures of the damage. At the end of the day, I believe there were four elements that contributed to this event. More on each of these in a moment.

- Lack of balanced rudder
- Addition of curved rudder fiberglass top, most of which weight was aft of the rudder hinge point
- Addition of electric rudder trim; where the trim motor, tab and hinge are all aft of the rudder hinge point
- Loose tail structure overall caused by numerous tailwheel shimmy incidents over the years—looseness which I didn't know about as I was remiss in never having grasped the vertical fin and attempted to move it side-to-side during a preflight.

Needless to say, I left the plane there, returning the following weekend with friends and a trailer. We took the plane apart and returned home to effect repairs.

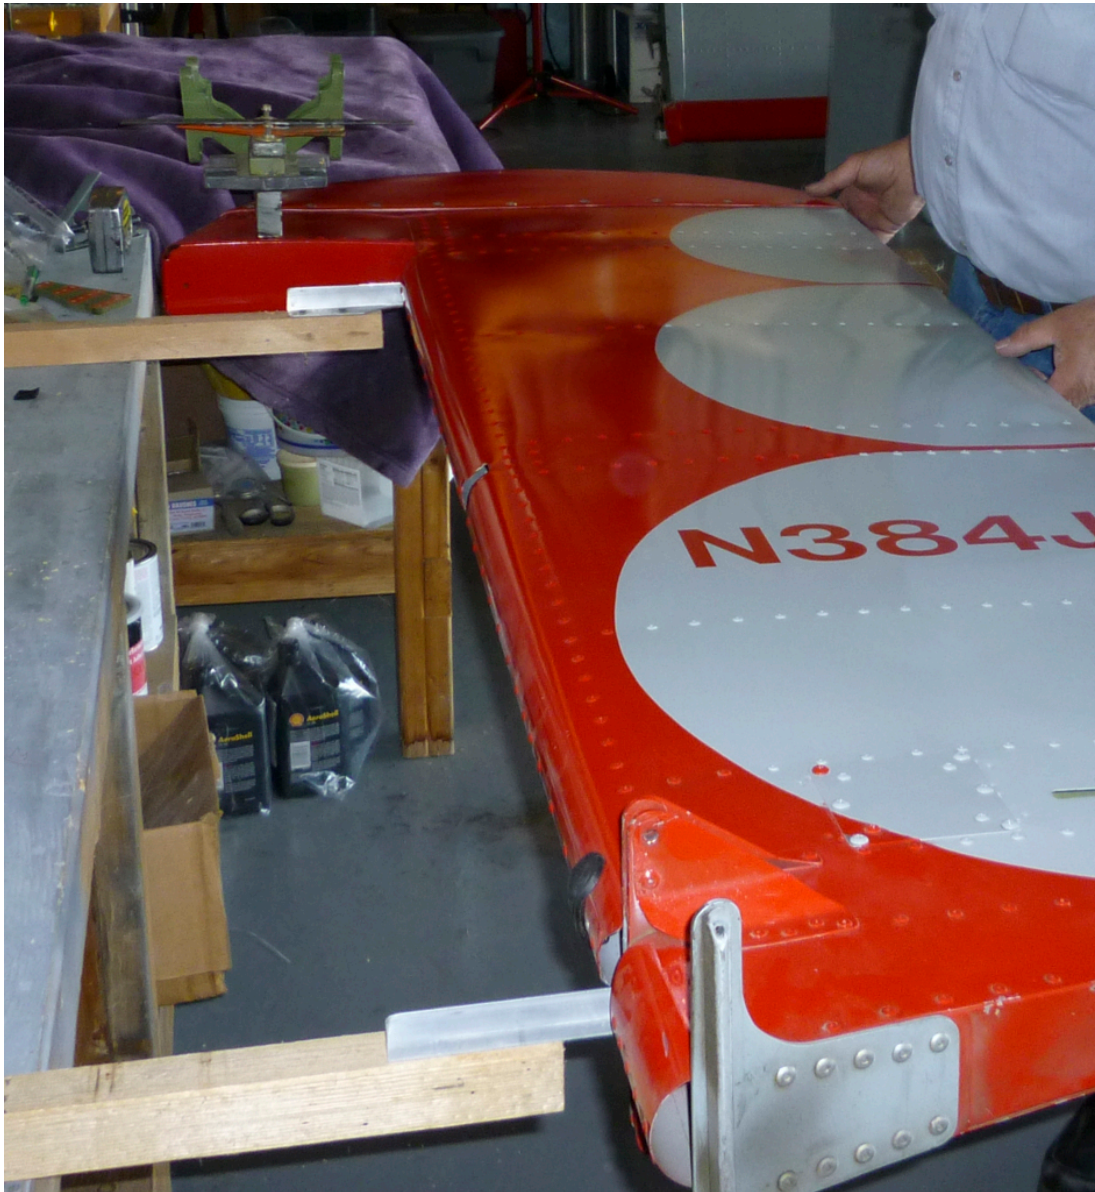
All of the literature and research on aircraft control flutter attributes flutter to having the control's center of gravity aft of the control hinge point. The universal method for avoiding the propensity for control flutter to ever occur involves adding weight forward of a control's hinge point—in other words “balancing controls.”

After this incident, and during the rebuild, I fully balanced all of the controls. This of course is the rudder balance process:

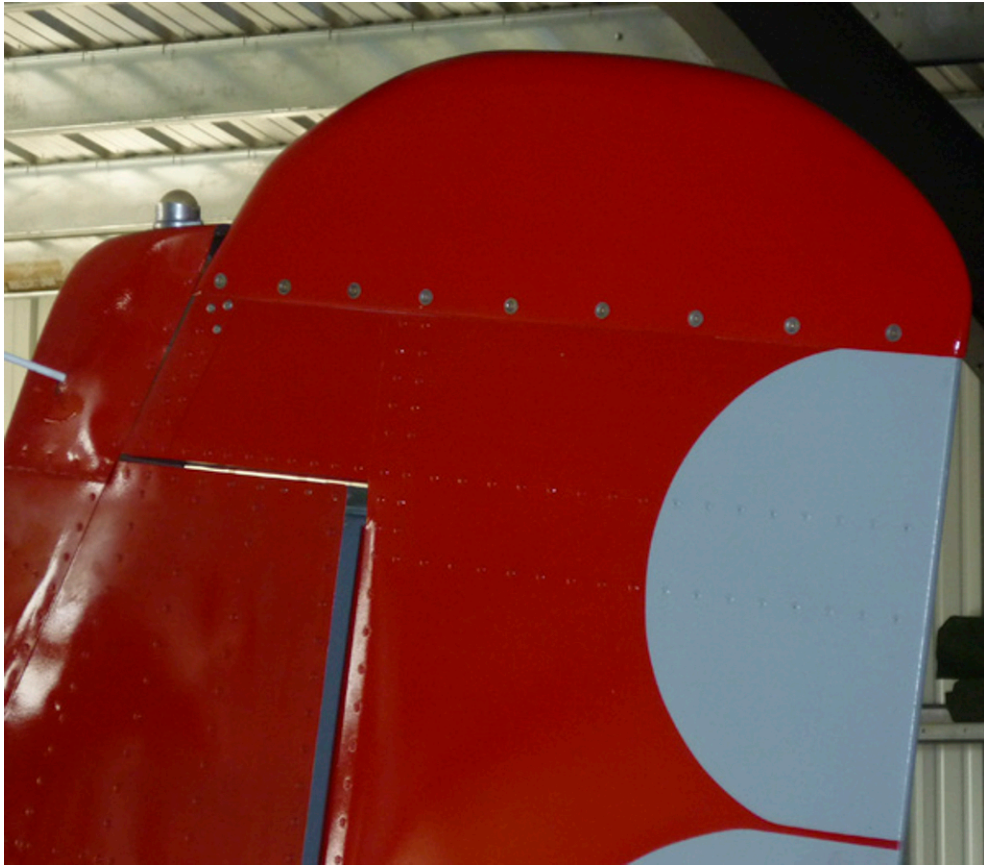
Seemed like a good idea. But at the time I didn't know I was adding a lot of weight aft of the control hinge point, making the propensity to flutter all that much greater.

Pictures show that during the rebuild I of course removed the top and reverted to the standard Murphy flat top rudder design.

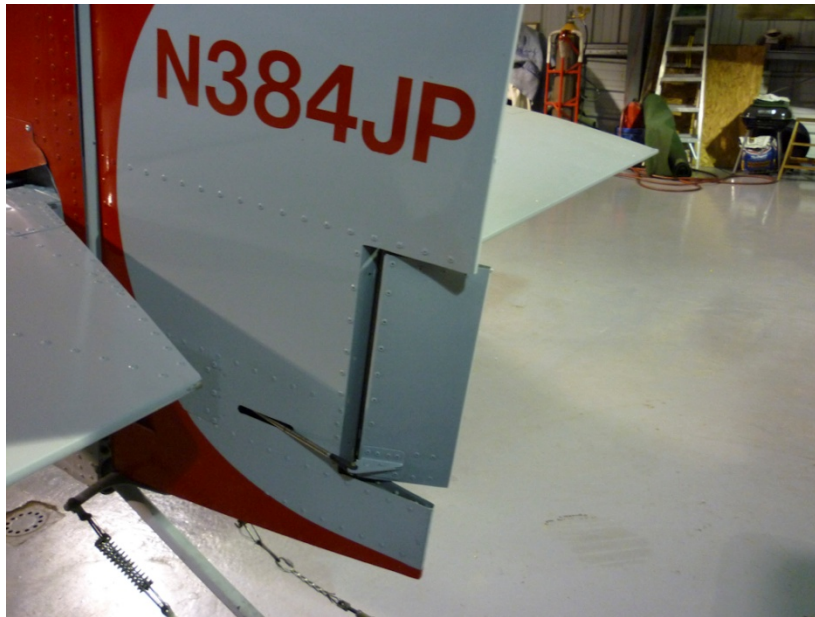
Most Moose builders I know added electric rudder trim. Again, weight with the trim motor and such behind the rudder hinge point.

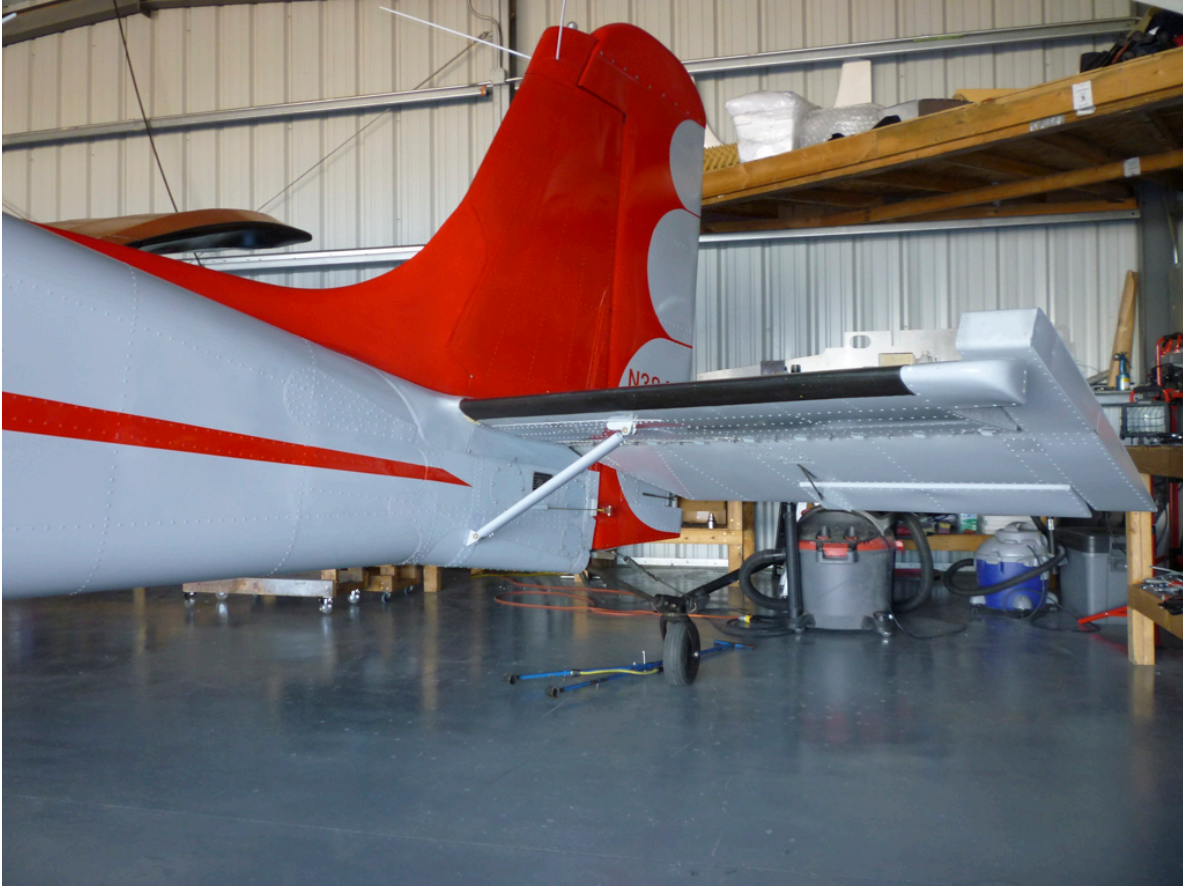
Over the years, with the standard Murphy tailwheel, I had off and on had a lot of tail wheel shimmy. Apparently, unbeknownst to me, this loosed the front spar of the vertical fin. Hence the whole vertical fin was able to move side-to-side to some degree. Again, I didn't know this (though I should have discovered such in pre-flight checks).

While the addition of the braces seen above was, and still is, likely a good idea, I believe this had the effect noted in the following paragraph. Others agree that the below summation is the best-guess rationale to the flutter incident itself.

Over time, in flight, the loose vertical fin—the whole tail structure—was able to find its own sweet spot. Everything was free to move—however slight—in all axis. The addition of the horizontal stabilizer braces restricted any tail movement to a single axis. For whatever reason—minor turbulence, a wind gust, control shift—flutter began. Thankfully, as described above, it only lasted a brief fraction of a second until the tail again found its new sweet spot.

A very experienced engineer friend, who also has an outstanding Moose that he built, did some horizontal stabilizer vibration analysis with some telemetry equipment that he had available (during another project). Long story short, he fabricated parts and built horizontal stabilizer braces—as seen on many types of aircraft. He built me a set of the same parts and which I installed as seen below:

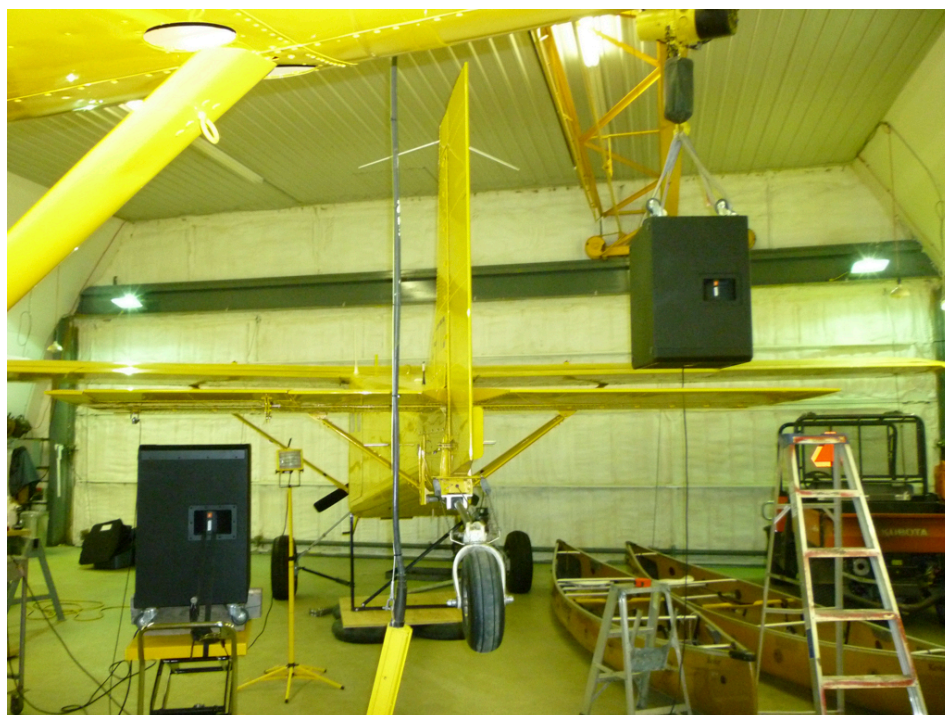
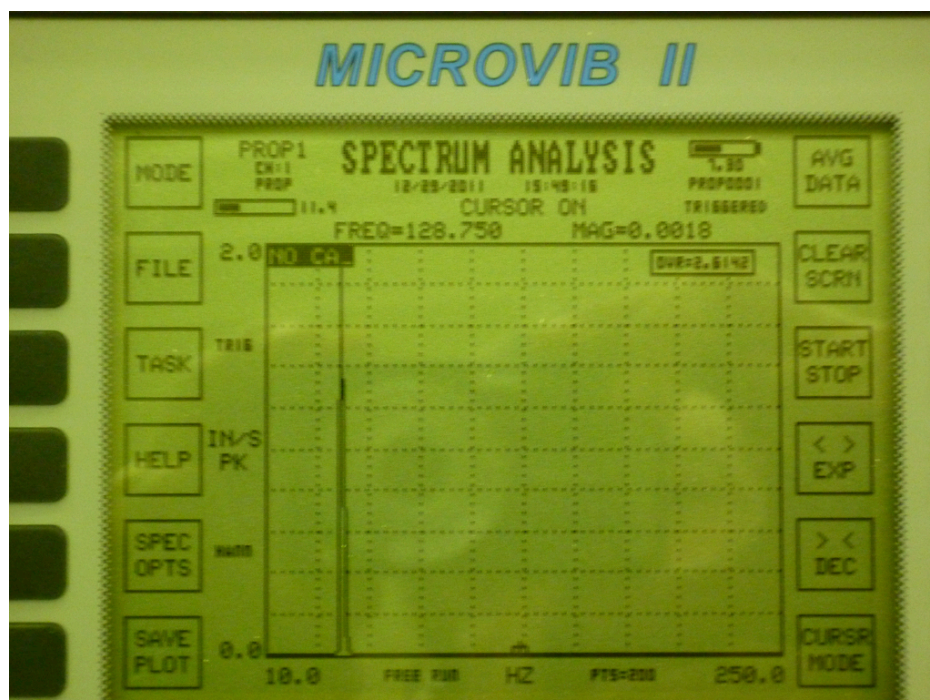
Myself and my above mentioned engineering friend/fellow Moose builder/pilot read every article we could find on flutter. We talked to an engineering firm. We then embarked on a detailed analysis of the Moose itself, using my friend's Moose, to see if there were any discoverable resonant frequency issues between the Moose fuselage, wings or controls. At the recommendation of an engineering firm, we suspended his plane on big rubber doughnuts, and used a spectrum analysis meter while we generated huge volume, large amplitude sound waves.

After several days of thorough analysis, we didn't find any issue whatsoever.
